DUAL ROTARY'S OVER-WASH CAPABILITIES

OVERWASHING CAPABILITIES

ABANDONED WELL OVERWASHING

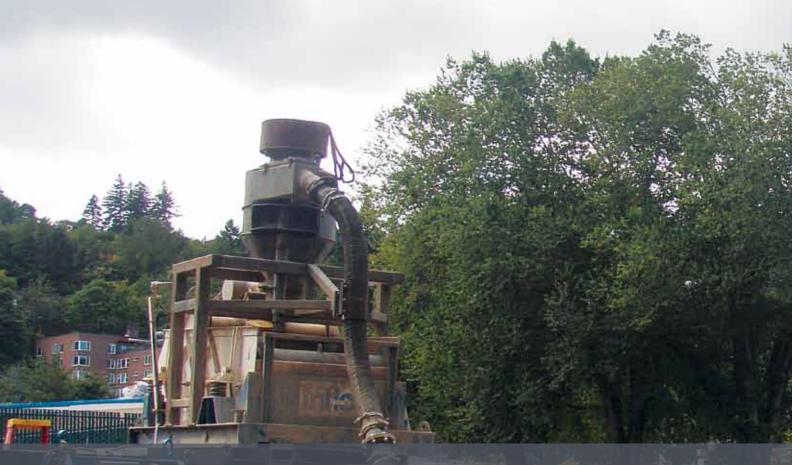
SUPERFUND SITE / OVERWASH A 400 FT, 16 INCH WATER SUPPLY WELL

The project called for the decommissioning of a 400 foot, 16-inch water supply well in a contaminated aquifer.

The contaminated aquifer was communicating with a clean aquifer, outside the casing within the annular space. Previous attempts were made to perforate and grout the inside of the well; however vertical communication on the back side of the casing was not stopped.

Dual Rotary was used to overwash a 21-inch diameter casing around the well. This created a 2.5-inch annulus around the original 16-inch casing and 20" borehole, completely removing the old seal and annular material.

The new annulus was completely sealed with grout, effectively isolating the clean zone from the contaminated zone. The original casing was then filled with grout to create a completely encapsulated well.
