# DUAL ROTARY'S OVER-WASH CAPABILITIES

# DUAL ROTARY

## OVERWASHING CAPABILITIES

## SUPERFUND SITE / OVERWASH A 400 FT, 16 INCH WATER SUPPLY WELL

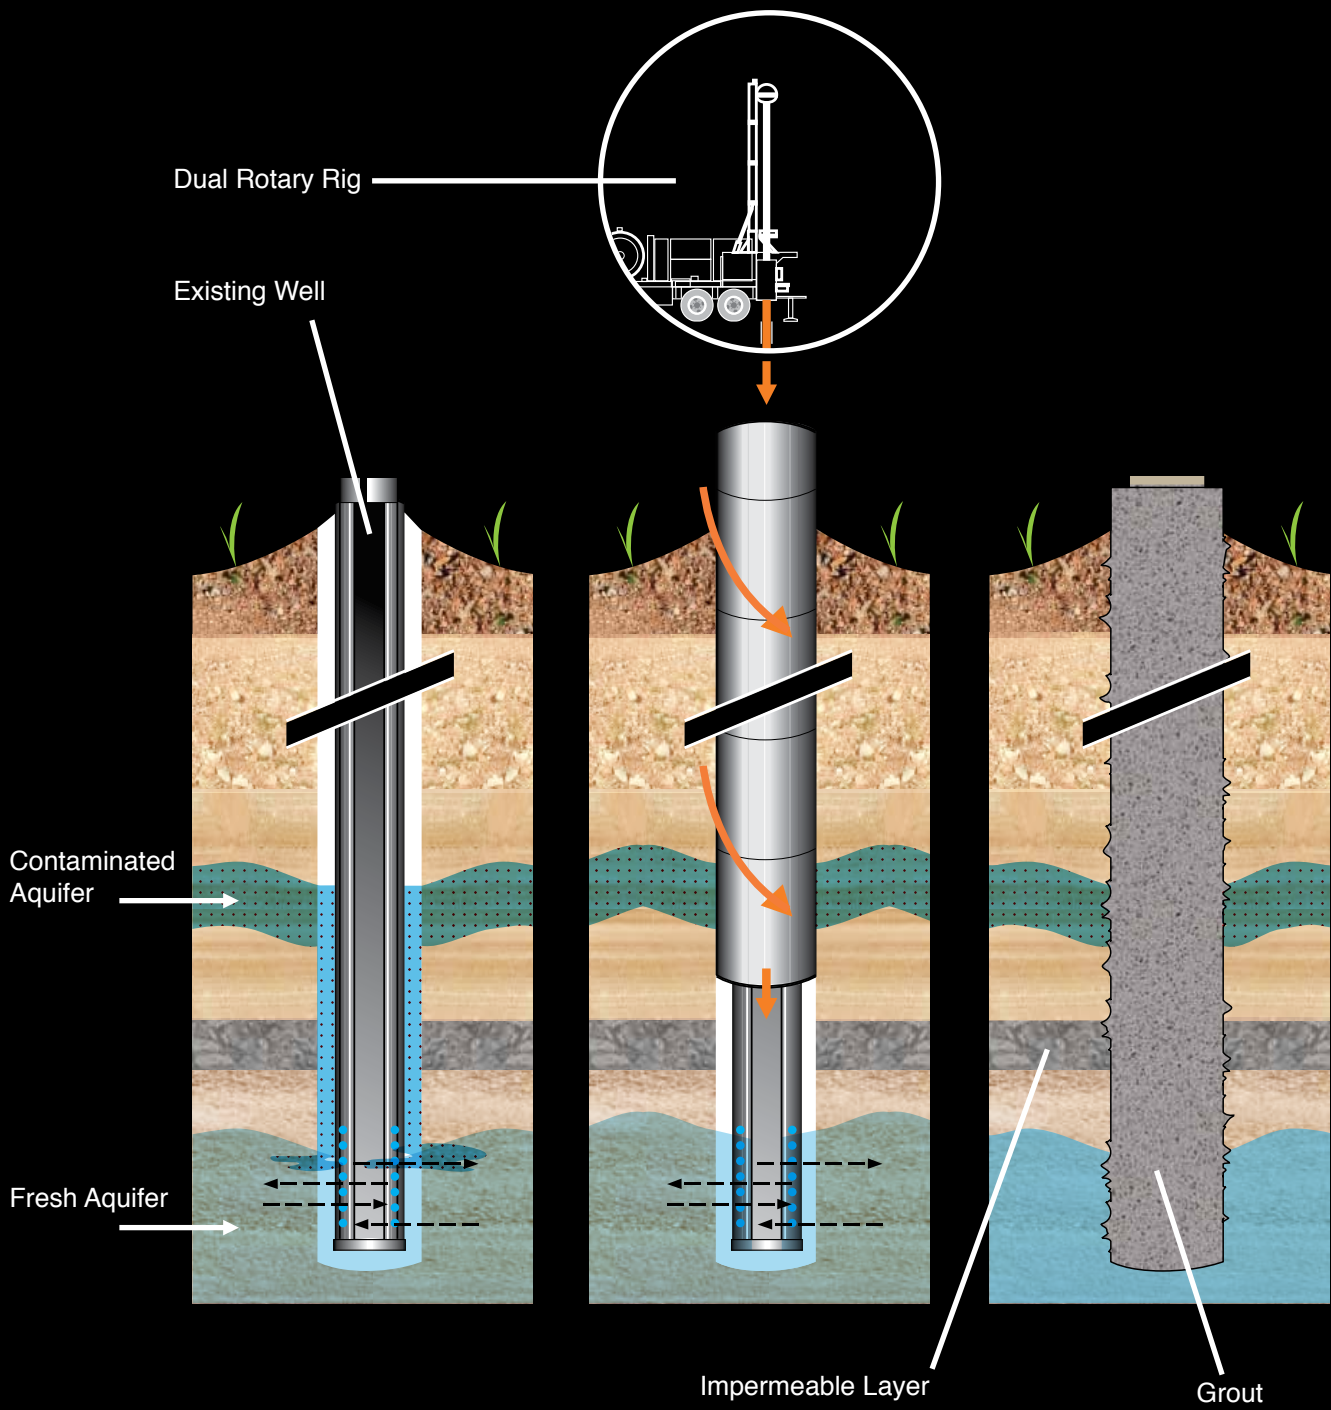
1. Contamination spreads through vertical communication with other aquifers.

2. Casing is overwashed (over original well) completely removing any seal or filter pack.

3. Entire annulus or borehole is grouted to the surface, effectively sealing off communication paths for contamination.

In many cases, multiple aquifers are contaminated due to a single well. This is caused by vertical communication between aquifers via water flow through and around the well casing. Traditional methods of abandonment typically leave the original sand pack around the well intact, which serve as a continued form of vertical communication.

- Overwash drilling advances a larger diameter casing over the original well, removing the entire gravel pack and any original annular material.
- The original well can be removed and the entire hole filled with grout.
- A new partial or complete annular seal can be installed around the existing casing.
- This process greatly reduces liability to the well owner.

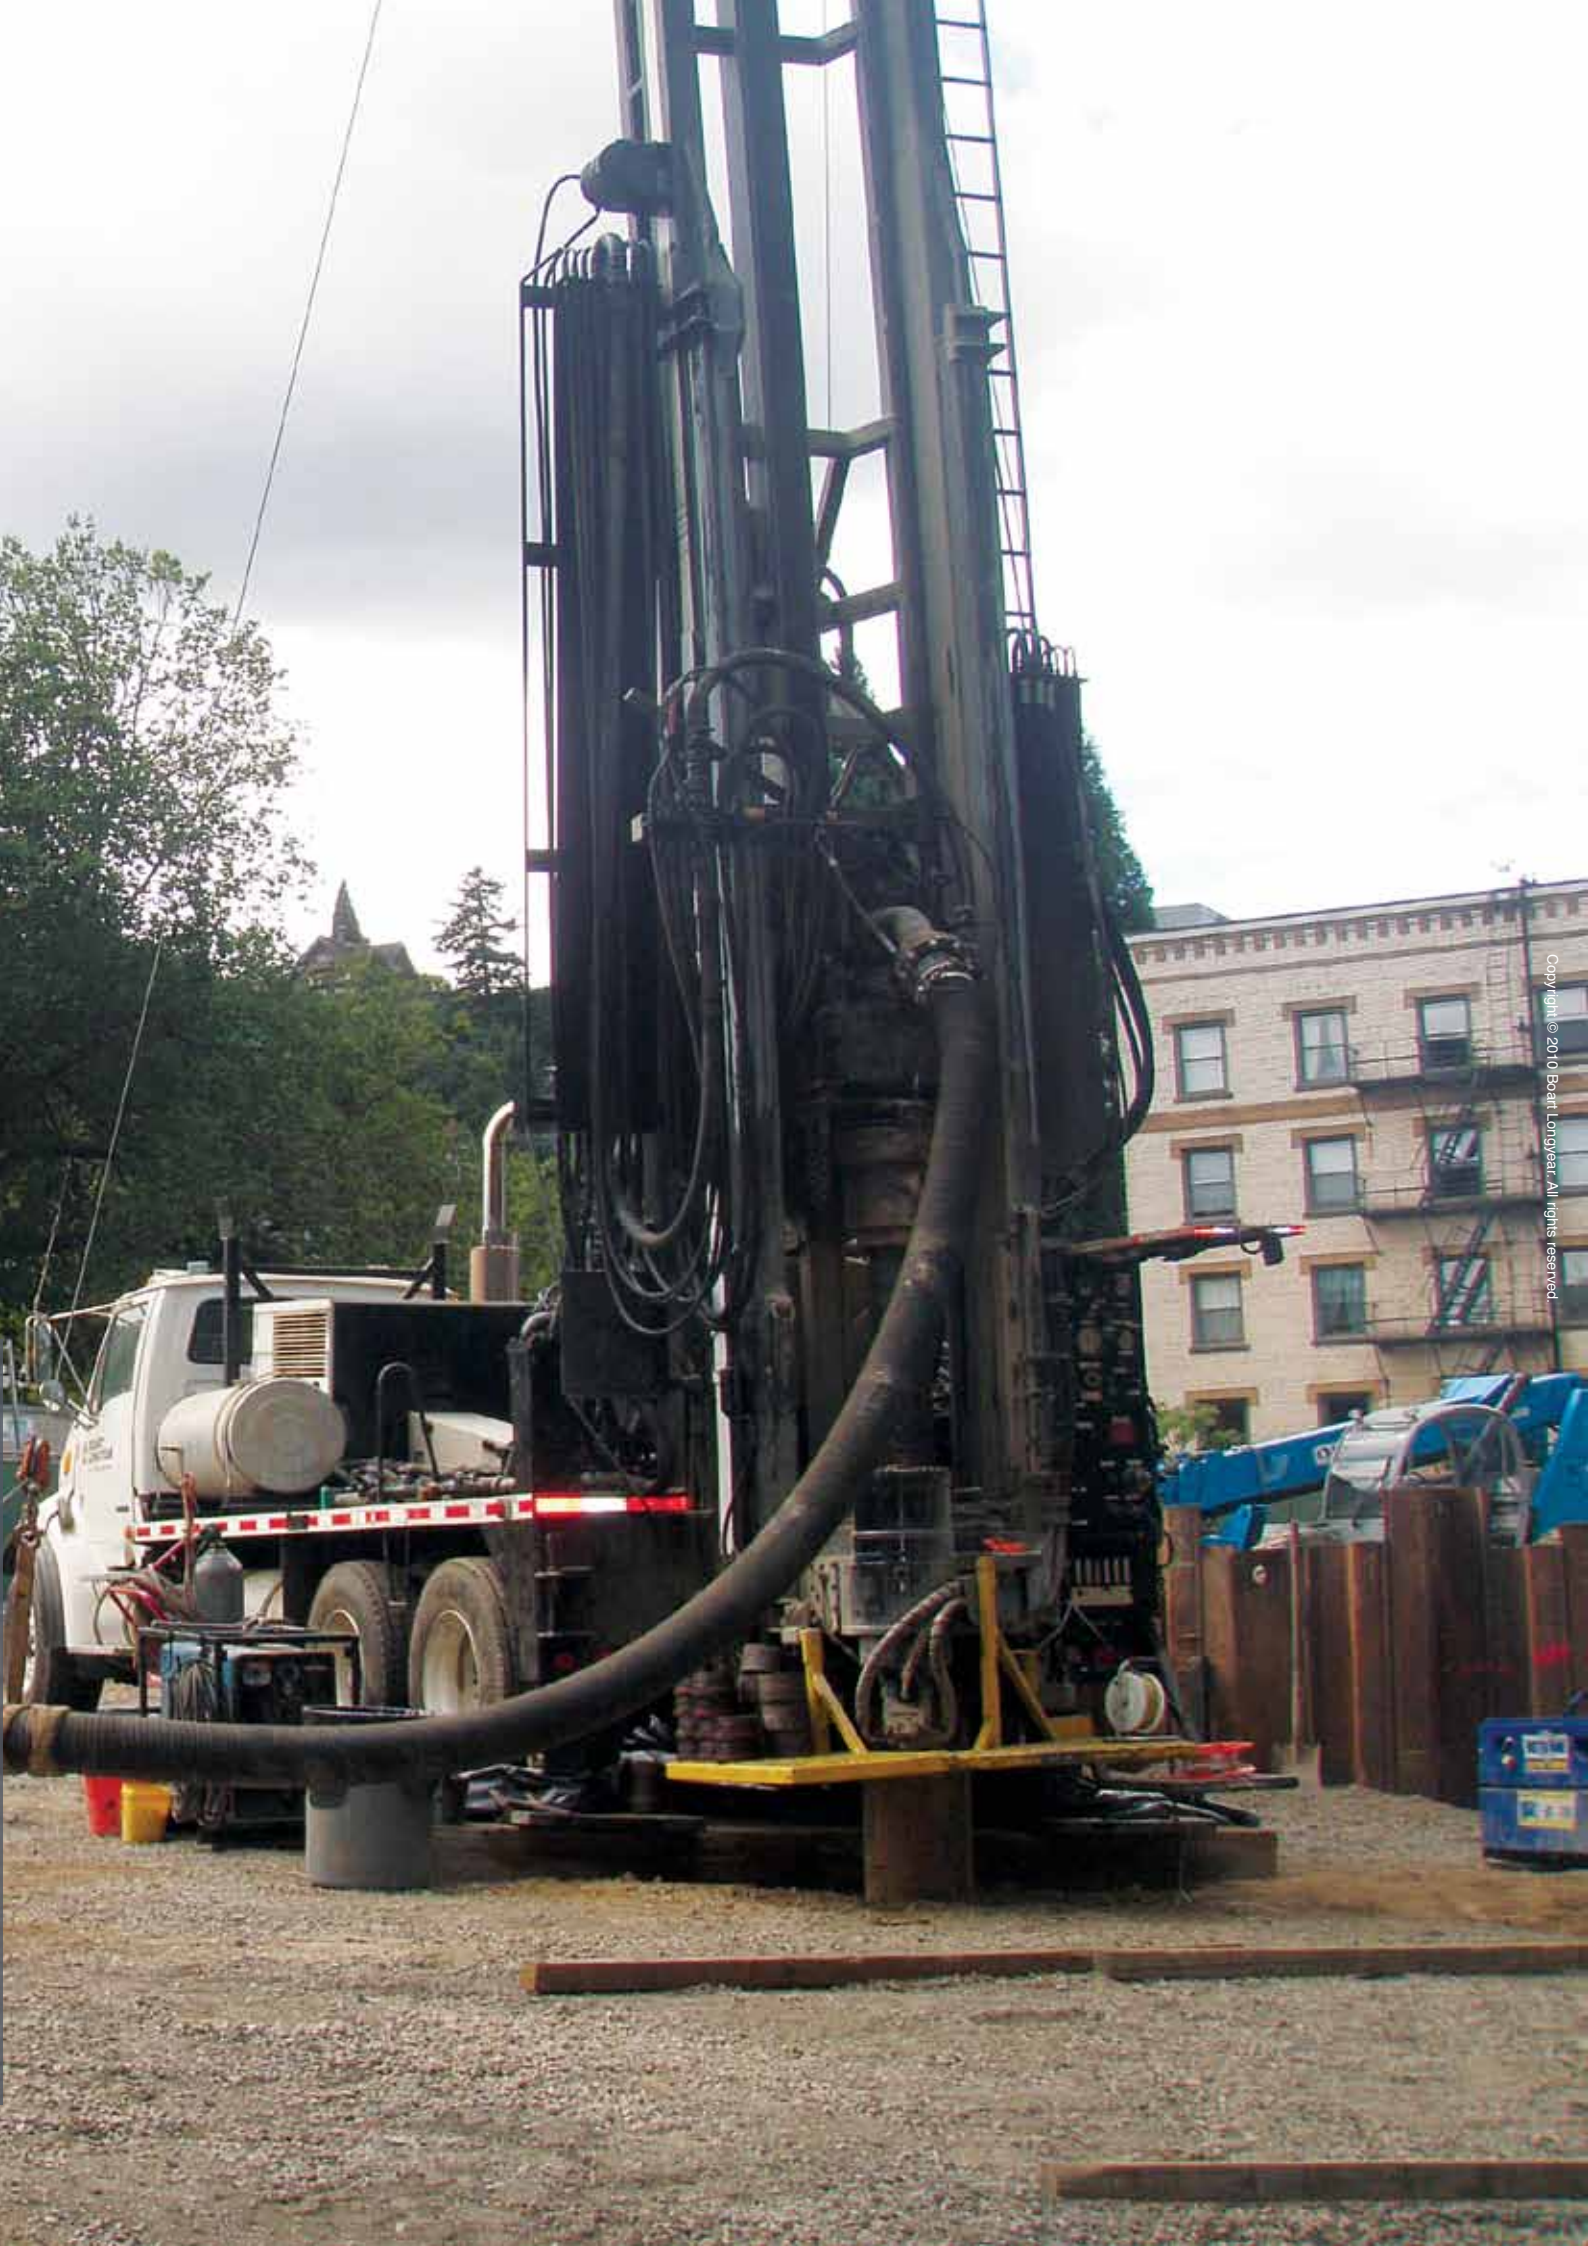
Dual Rotary was used to overwash a 21-inch diameter casing around the well. This created a 2.5-inch annulus around the original 16-inch casing and 20" borehole, completely removing the old seal and annular material.

The new annulus was completely sealed with grout, effectively isolating the clean zone from the contaminated zone. The original casing was then filled with grout to create a completely encapsulated well.
